# CFIT Awareness and Prevention

## Additional Causes For CFIT Revealed By The 1991 DuPont G-II Crash In Malaysia

—  
*Roger K. Parsons, Ph.D.*

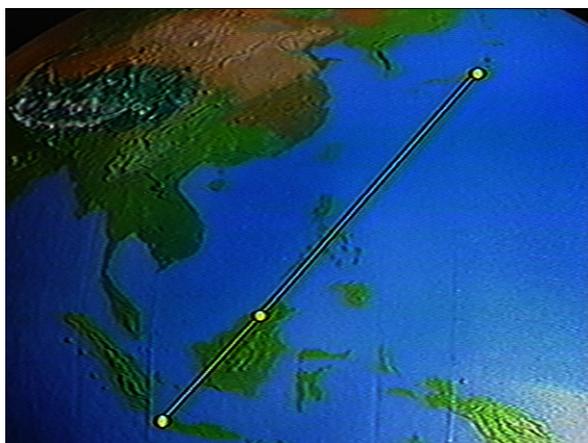
### **EXHIBIT 1. TOKYO-JAKARTA (18:06)**

The FSF account does not reveal that DuPont's pilots left Houston planning to use Okinawa, Japan as the fuel stop along the route depicted in **EXHIBIT 1**; nor does it explore the poor planning done by DuPont's pilots for the fuel stop at Kota Kinabalu (See **Ad-lib Trip Plan.**)

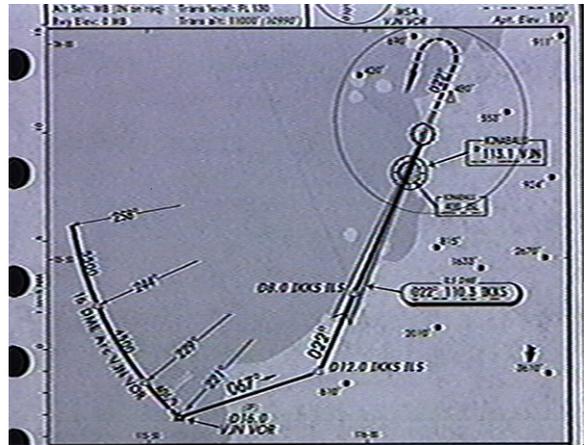
**EXHIBIT 2. ILS APPROACH PLATE (18:39)**

The "ILS DME ARC" approach shown in **EXHIBIT 2** was inoperative on September 4, 1991. DuPont was responsible for making sure that its pilots were provided the NOTAM, published months before, stating that this approach was inoperative before these pilots departed Tokyo. If the pilots were planning to use the "ILS DME ARC" or the "VOR DME ARC" approach shown on the approach plate in the FSF video, then they should have requested their approach procedure preference by its published name. These pilots did not.

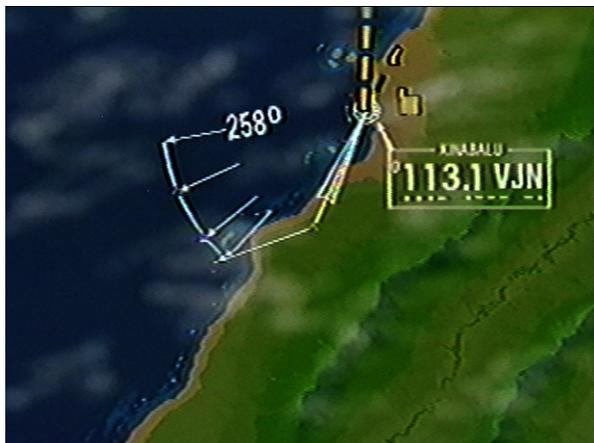
**EXHIBIT 3. INBOUND GROUND TRACK (18:48)**

The inbound ground track depicted is false. Positions of the DuPont aircraft reported by the pilots to the controller show that the aircraft did not track inbound to the VOR as shown in **EXHIBIT 3**. The DuPont aircraft flew inbound on the 025° VOR radial.

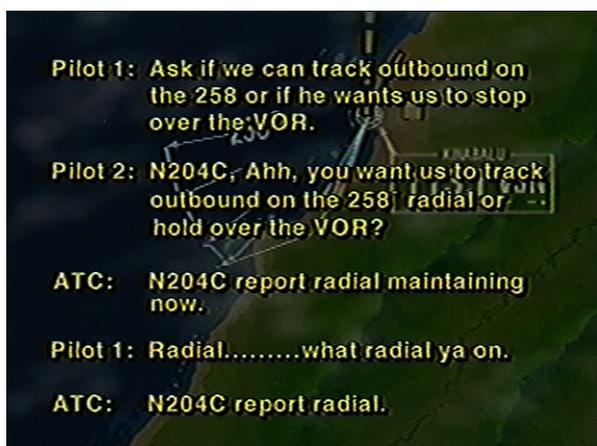
**EXHIBIT 4. CVR TRANSCRIPT PAGE 1 (18:55)**

Repeatedly the CVR recording is misinterpreted to mask these pilots' incompetence and to advance the DuPont-AIG story.<sup>3</sup> The poor reproduction of the CVR recording onto the audio track of the FSF video obscures the copilot's "What?" that occurs between when the pilot says: "Radial" and when the pilot says: "What radial ya on." (**EXHIBIT 4**). At this time, the controller expects the DuPont aircraft to reach the VOR more than fourteen minutes later.

The pilots do not tell the controller that their aircraft was almost over the VOR. In this context the controller could not understand why the copilot would ask about "the two five eight degree radial".

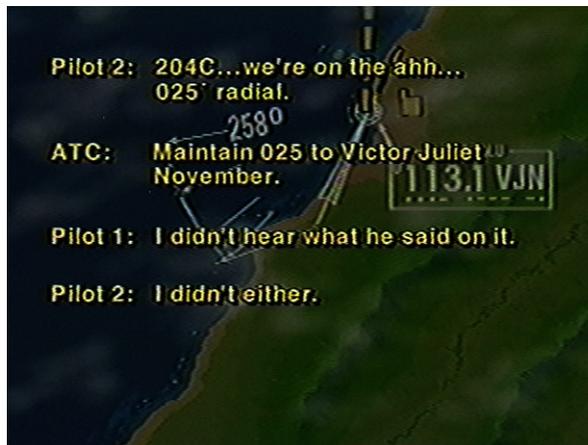
**EXHIBIT 5. CVR TRANSCRIPT PAGE 2 (19:23)**

The pilot's do not ask the controller for a specific approach by ICAO-standard name or tell the controller that their aircraft is about to pass their clearance limit in a few seconds. The controller properly directs the pilots to maintain the 025° radial inbound to the VOR, expecting their arrival in fourteen minutes (**EXHIBIT 5**).

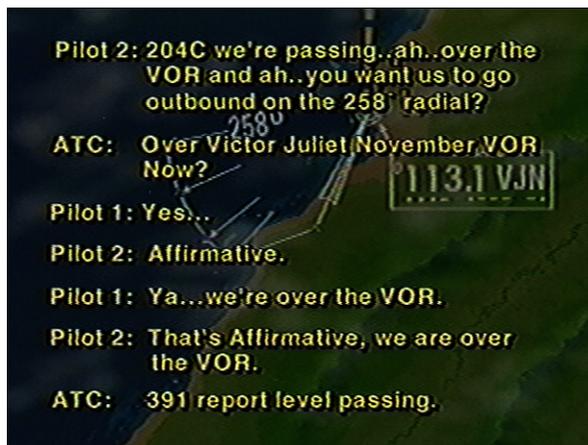
**EXHIBIT 6. CVR TRANSCRIPT PAGE 3 (19:37)**

When the controller is finally told that the DuPont aircraft is over the VOR unexpectedly early (**EXHIBIT 6**), he immediately fulfills his sole responsibility -- air traffic control. The controller requests an altitude report from the Malaysian airliner, MAS 391, on its approach to assure adequate altitude separation between the DuPont aircraft and airliner.

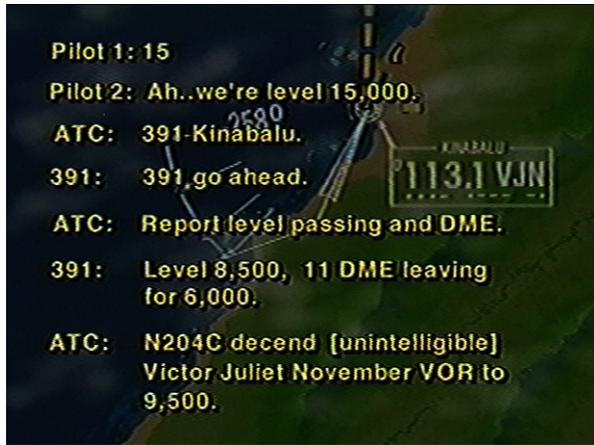
**EXHIBIT 7. CVR TRANSCRIPT PAGE 4 (20:05)**

DuPont's pilots mistakenly answer the controller's request to the airliner (EXHIBIT 7). In another example of bad communications skills, the DuPont copilot reports his altitude without identifying his aircraft.

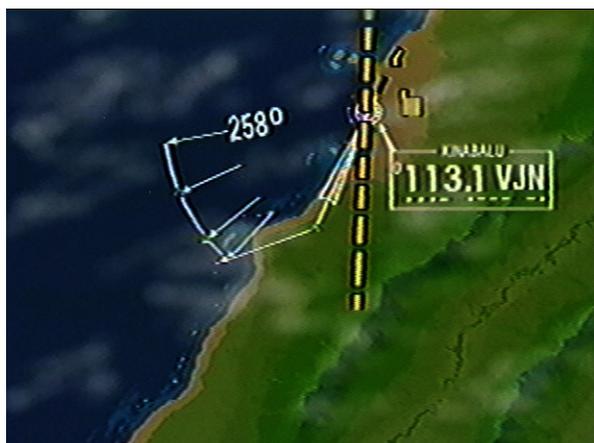
**EXHIBIT 8. OUTBOUND TRACK (20:31)**

The outbound ground track depicted is false. The outbound track from the Kota Kinabalu VOR depicted in EXHIBIT 8 is impossible for DuPont's pilots to have flown for the following reasons.

- If the aircraft was flown over terrain along 180° VOR radial on the descent DuPont's pilots reported to the controller, then, the aircraft would have crashed more than a minute before it actually did.
- The time period between when the pilot tells the copilot: "I'm gonna turn to the right." and when the aircraft hit the trees is too short for the aircraft to have flown from the 180° VOR radial to the point of initial impact. To fly the three nautical miles from the 180° VOR radial to the crash site in the twenty-five seconds would require ground speeds exceeding 430 knots at an altitude less than 4,000 feet.

The “belief” that the aircraft “departed the Kinabalu VOR on a one eight zero degree track” is wrong. It would be impossible for DuPont’s pilots to have flown their aircraft along the 180° VOR radial on the descent reported to the controller. (See comments under **EXHIBIT 8**.)

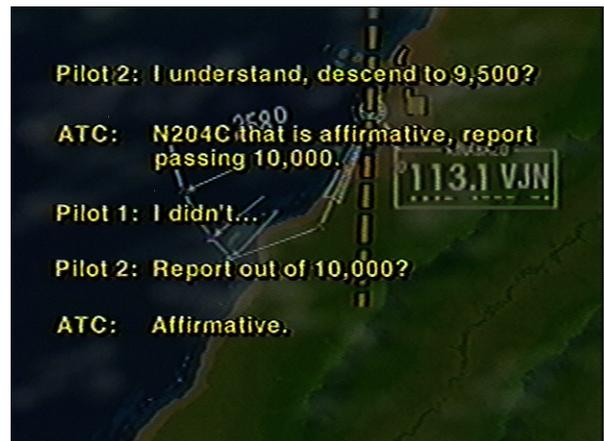
**EXHIBIT 9. CVR TRANSCRIPT PAGE 5 (20:35)**

The transcript shown in EXHIBIT 9 is incorrect. In fact, the copilot says clearly: "We understand descend to nine thousand five hundred." The copilot's inflections are not questioning; rather, he indicates that he understands the controller's directive and will comply. However, the copilot's response is automatic, out of bad habit and poor training, and does not indicate true understanding.

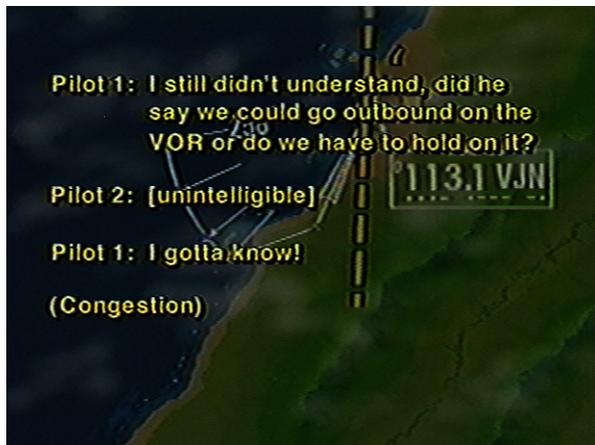
EXHIBIT 10. CVR TRANSCRIPT PAGE 6 (20:53)

The author's interpretation of the CVR again masks the inadequacies of the pilots. The "[unintelligible]" the author shows in **EXHIBIT 10** is in fact the copilot saying: "I don't know." To which the pilot exclaims, in an irritated tone: "I gotta know!" After the pilot's exclamation, the copilot is heard to say docilely: "Yeah."

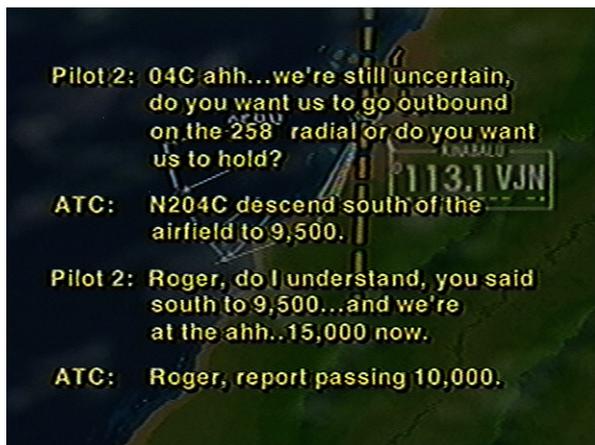
EXHIBIT 11. CVR TRANSCRIPT PAGE 7 (21:21)

The transcript shown in **EXHIBIT 11** is false. The copilot does not say "Roger, do I understand you said south to 9,500...". The copilot actually says, not as a question but in confirmation: "Roger, *understand* you said south to nine thousand five hundred."

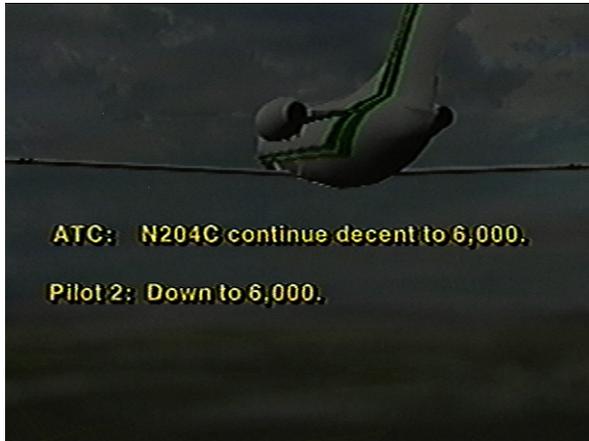
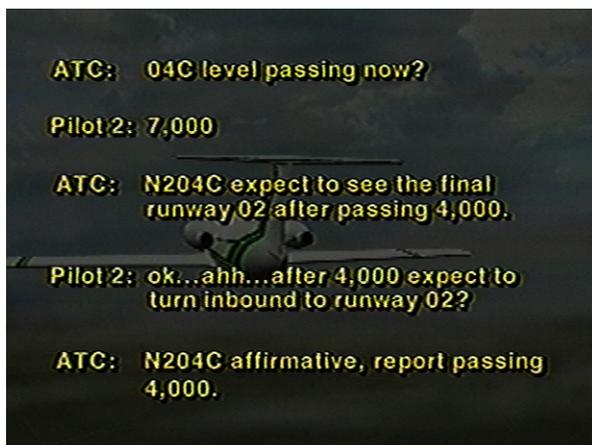
The CVR recording has been cut-and-pasted to present a distorted version of the events leading to this crash. If the recording must be cut-and-pasted into an abridged version of what actually occurred, then the transcript should at least indicate the times that statements are made. The fact that nothing happens in the cockpit for the minute and forty-five seconds between the segment of CVR recording transcript shown in **EXHIBIT 12** and the segment shown in **EXHIBIT 13**, not even conversation between the pilots, reveals that these pilots flew their aircraft to disaster in relaxed ignorance.

In particular, for two minutes following the controller advising the pilots that he would clear the aircraft to turn inbound on the runway center-line when their aircraft reached four thousand feet (**EXHIBIT 12**), DuPont’s pilots failed to bring their aircraft closer to the runway center-line for timely compliance with the expected directive. Instead, DuPont’s pilots continued to fly their 180° heading farther from the runway center-line. From where they were when the directive was given to turn inbound, the aircraft was over three minutes flying-time to the closest point on the runway center-line.

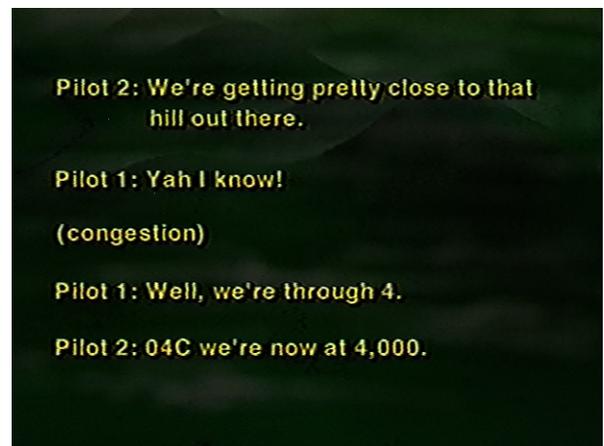
**EXHIBIT 14.** CVR TRANSCRIPT PAGE 10 (23:25)

The CVR transcript shown in **EXHIBIT 14** is false. The copilot says “We’re getting pretty close to the hills here.” The pilot responds: “Yeah, I know. Tell’em we’re through four.” As close as their aircraft was to eye-level “hills”, the pilot should have known that he was violating US and Malaysian regulations on aircraft-terrain clearance<sup>4</sup> and he should have immediately aborted his descent. Then, the pilot should have reported his position and altitude to the controller and asked for help.

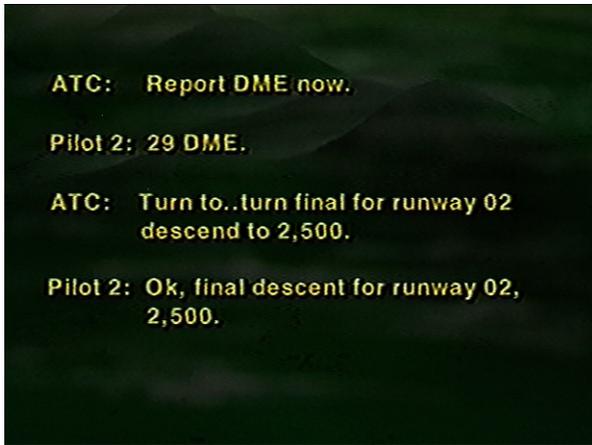
EXHIBIT 15. CVR TRANSCRIPT PAGE 11 (23:38)

The CVR transcript shown in **EXHIBIT 15** is incorrect. Once the DuPont aircraft descended to four thousand feet the controller tells the pilots: "You are cleared to... join final for runway zero two, descend to two thousand five hundred."

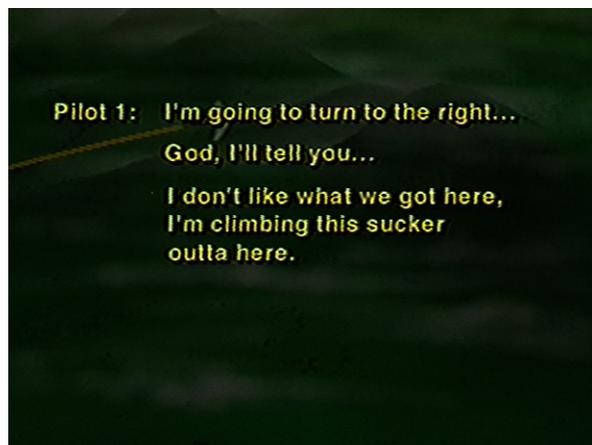
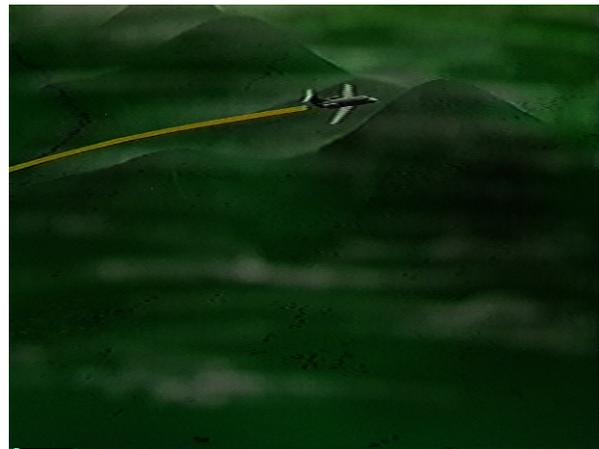
The topography depicted in **EXHIBIT 14**, **EXHIBIT 15**, **EXHIBIT 16**, and **EXHIBIT 17** is greatly exaggerated. The actual topography along the DuPont aircraft flight path is less steep. The average slope along the last six nautical

miles of the flight path is less than 20° and, because the aircraft flew over a shoulder of one ridge and up the crest of another ridge, the average slope along the last four nautical miles of the flight path is less than 6°.
